DMS-100

Universal Edge 9000

Data Testing and Troubleshooting Guide

NA015 Standard 01.01 March 2001

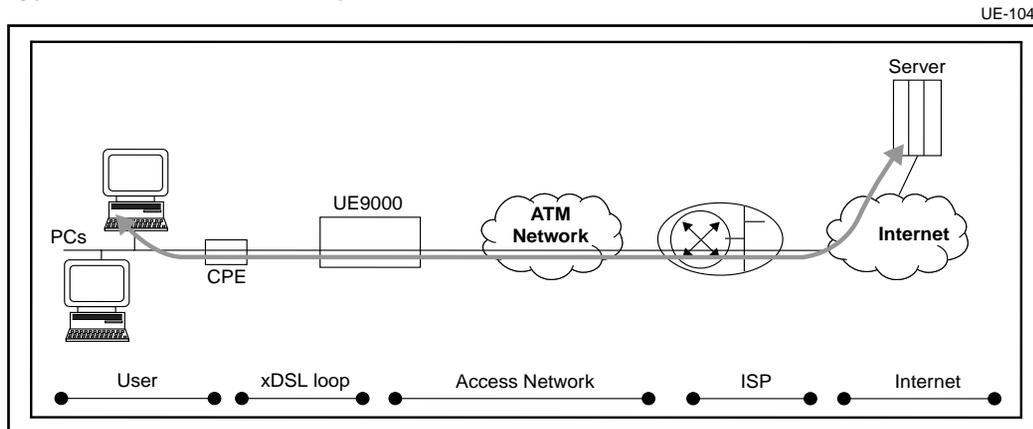
Figure 1-1 shows the various portions of an end-to-end user data path, from the customer premises to a server on the internet.

Figure 1-1
Typical end-to-end user data path

Elements that can influence the data transfer rate occur in all locations within the network. In general they include processing speeds (PCs, network switching equipment, routers, servers), buffer sizes, protocol implementations, line speeds (access links, network trunks), delays (modulation/error correction, propagation, queuing, processing), error rates (transmission errors, packet discards due to congestion), and packet size.

One approach to isolating the source of the problem is to provide a server within the UE9000 access network that can be accessed by end users for test purposes. As shown in [Figure 1-1 on page 1-3](#), the server could exist within the ISP cloud. Since this server is within or close to the access network, it can have predictable performance.

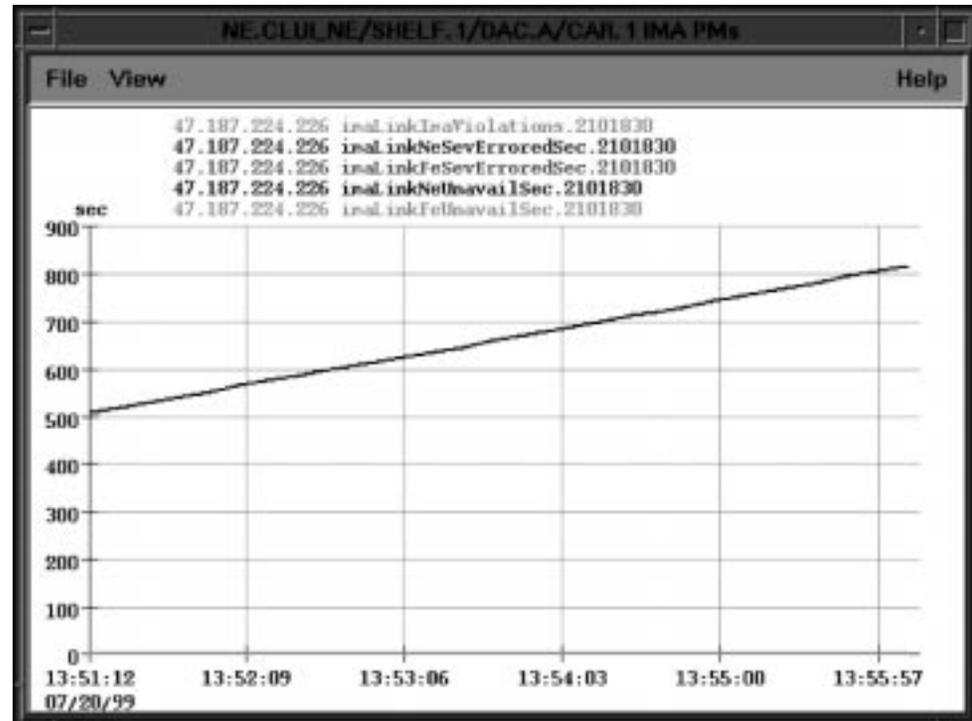
Figure 3-1 shows a sample performance monitoring graph.

Figure 3-1
Sample performance monitoring graph

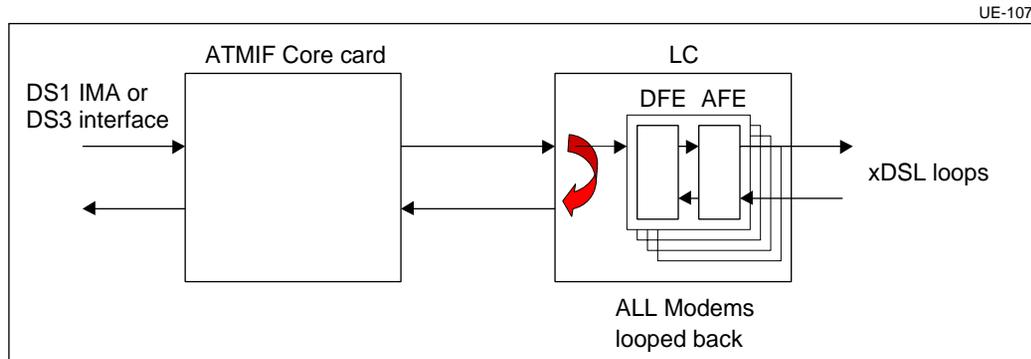
This test loops ATM cells back toward the carrier network interface at the backplane interface to the line card. During the test, all of the line card circuitry is isolated. You can use this test to verify the ability of the ATM card and the backplane to properly handle ATM cells.

Figure 3-2
ATM loopback upstream test

- is service affecting for all line circuits on the line card
- runs continuously until manually stopped
- can be run while the line card is either locked or unlocked
- cannot be run at the same time as the ATM loopback downstream test

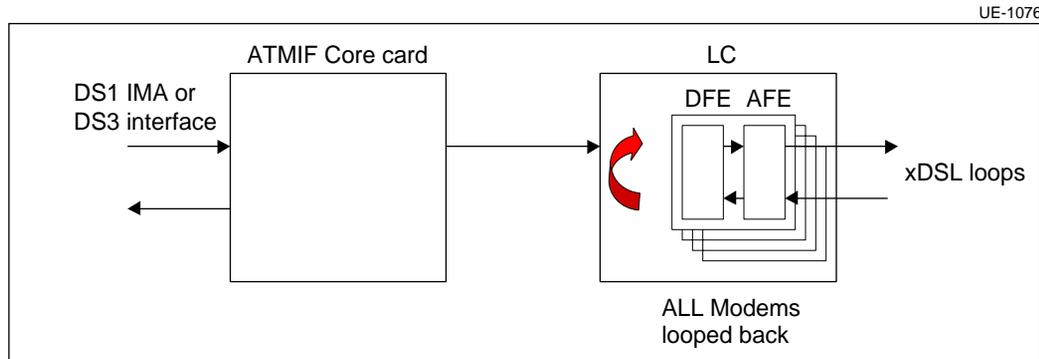
This test loops ATM cells through the line card back toward the customer premises equipment (CPE). During the test, the ATM card and the backplane circuitry are isolated. You can use this test to verify the CPE, subscriber line, and most of the modem circuitry.

Figure 3-3
ATM loopback downstream test

- is service affecting for all line circuits on the line card
- runs continuously until manually stopped
- can be run only while the line card is locked
- cannot be run at the same time as the ATM loopback upstream test

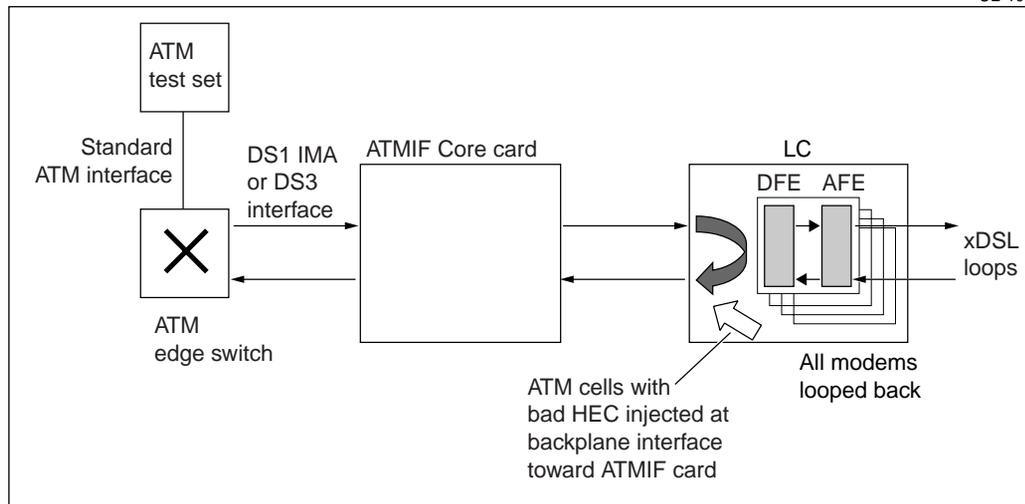
Figure 3-4
Inject bad HEC upstream test

- is service affecting for all line circuits on the line card
- runs continuously until manually stopped
- can be run while the line card is either locked or unlocked
- can be run at the same time as the ATM loopback upstream test

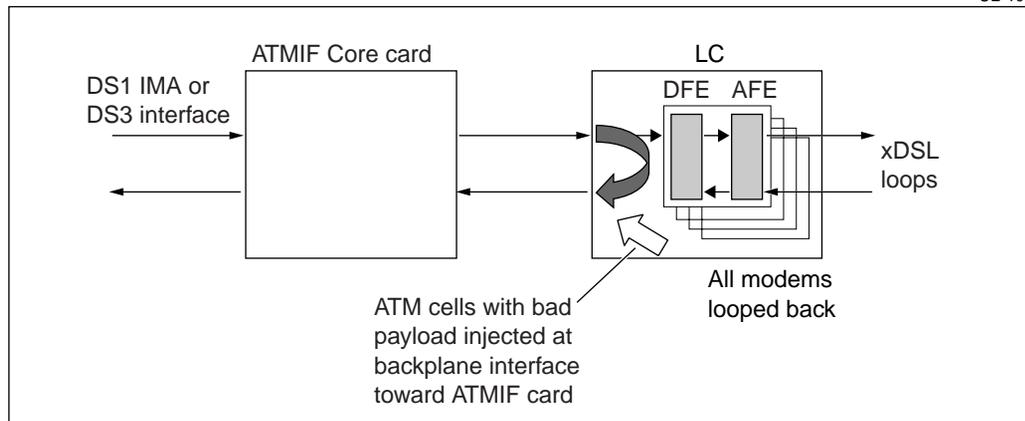
Figure 3-5
Inject bad payload upstream test

- is service affecting for all line circuits on the line card
- runs continuously until manually stopped
- can be run while the line card is either locked or unlocked
- can be run at the same time as the ATM loopback upstream test and the inject bad HEC upstream test

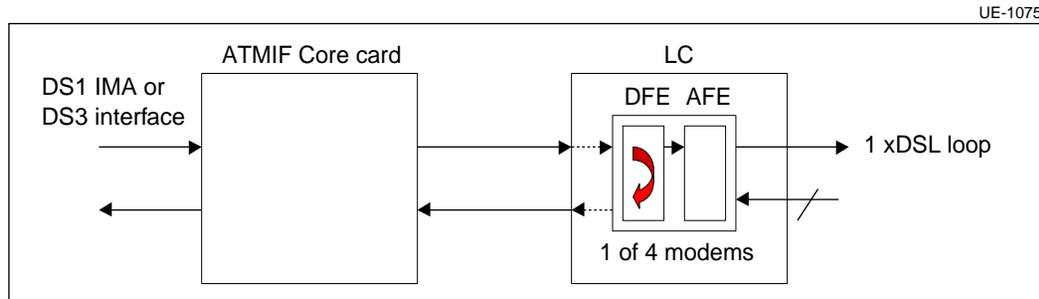
This test loops ATM cells back toward the carrier network interface at the ATM cell interface to the line card modems. You can use this test to verify the line card ATM cell mux/demux and a portion of the modem digital front end. This test also verifies the integrity of the ATM card and the backplane.

Figure 3-6
DMT utopia loopback upstream test

- is service affecting for all line circuits on the line card
- runs continuously until manually stopped
- can be run only while the circuit is locked
- cannot be run at the same time as any other test

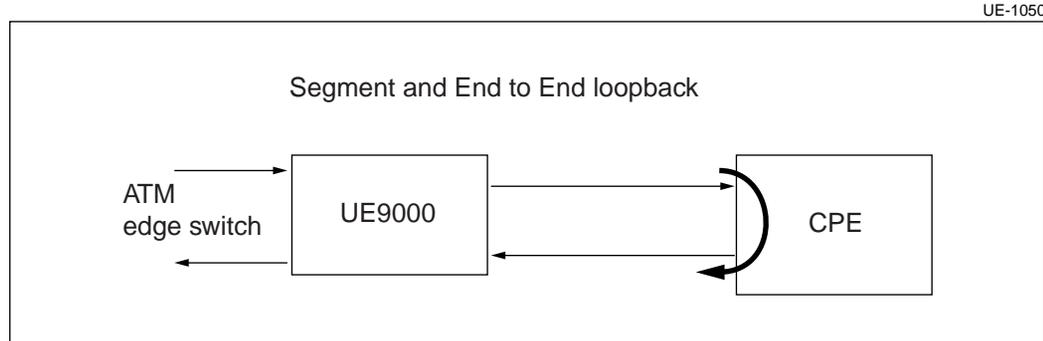
- can be received by or originated from the UE9000 shelf
- runs once (not continuously)

Figure 3-7
Access side loopback

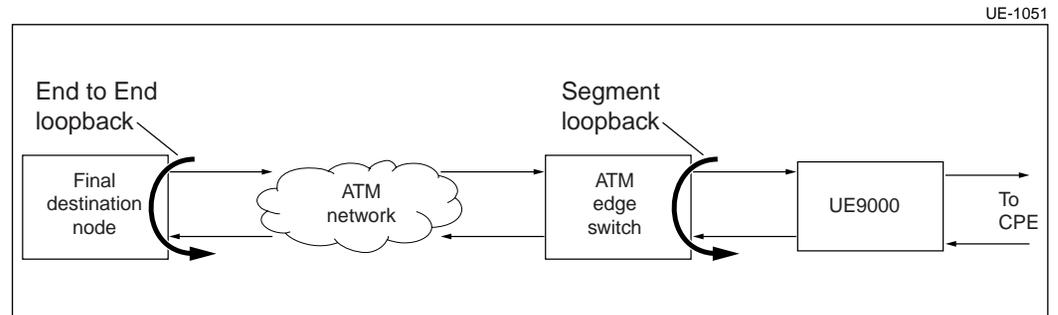
Performing the one-shot loopback test**Figure 3-8**
Network side loopback

Step	Action
1	From the LC submap, open the circuit pop-up menu and select Maintenance -> VCC -> Test: one shot loopback <i>A dialog box appears where you can enter the test parameters.</i>
2	In the VCC number field, enter a number from 1 to 8 . This number determines which cross-connect is tested.
3	In the Segment or EndtoEnd field, enter vcSegment or vcEnd2End . This parameter determines whether the test is for the segment or the final destination node.
4	In the Access/Network side field, enter Access or Network . This parameter determines whether the test is for the subscriber loop (Access side) or the network (Network side).
5	Click OK to start the test. <i>The test begins. The test results indicate either pass or fail.</i>
